UV Sterilizers come in many lengths and diameters

Delta UV Assembled

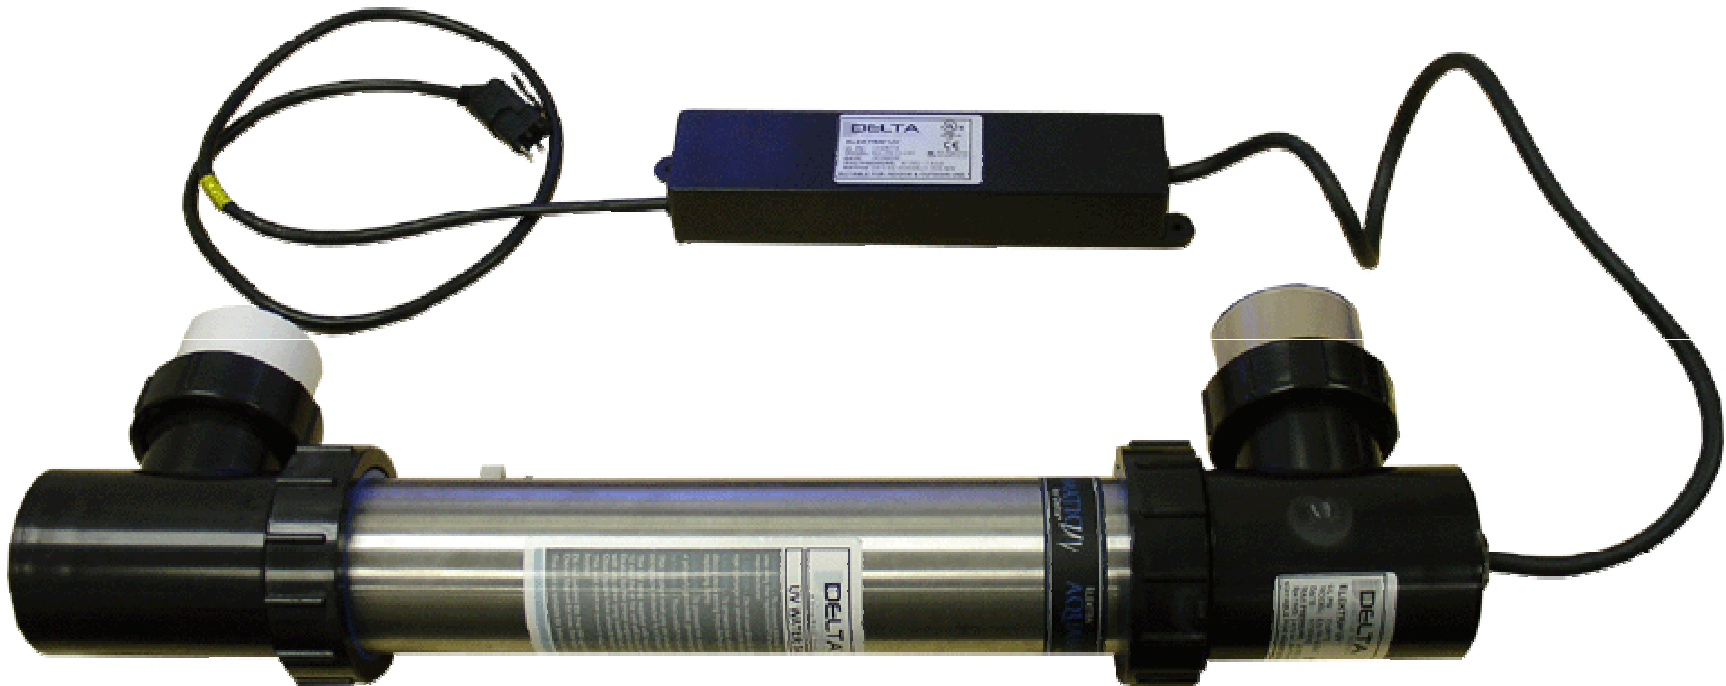
The Delta UV will be used as an example. Essentially spa water flows through the stainless tube housing which holds a light bulb which radiates passing germs and makes them incapable of reproducing.

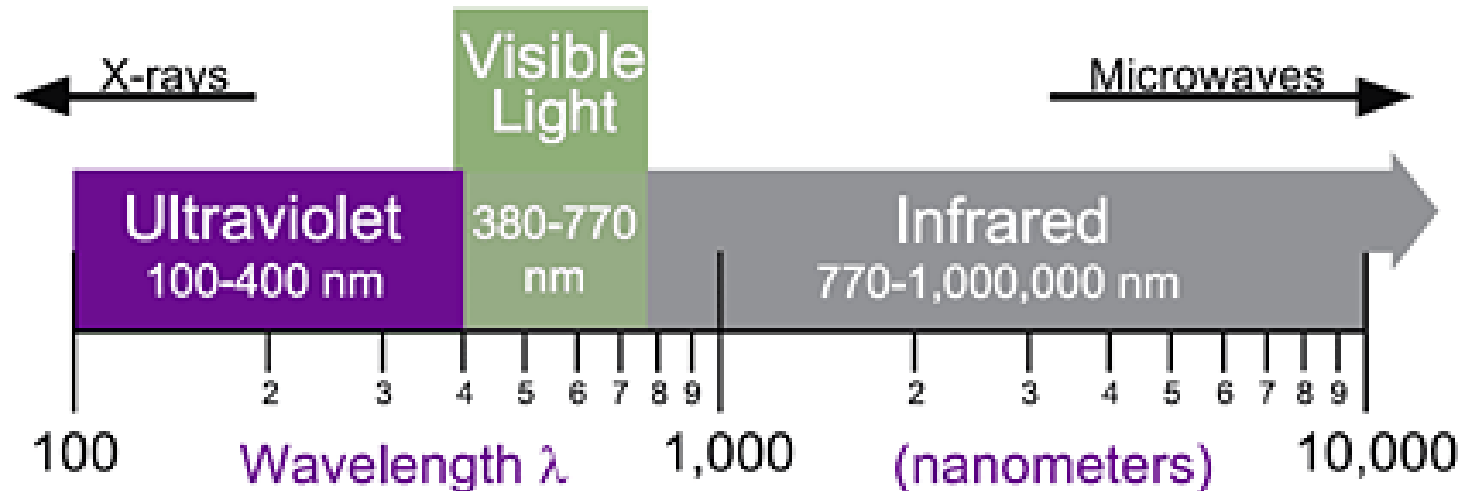
UV Sterilizer (Light Spectrum)

UV is an abbreviation for Ultraviolet light, which is a spectrum of light just below the range visible to the human eye. That is to say UV light is below the blue spectrum of visible light. So UV light cannot be seen by the human eye, and for that reason is often called UV energy.

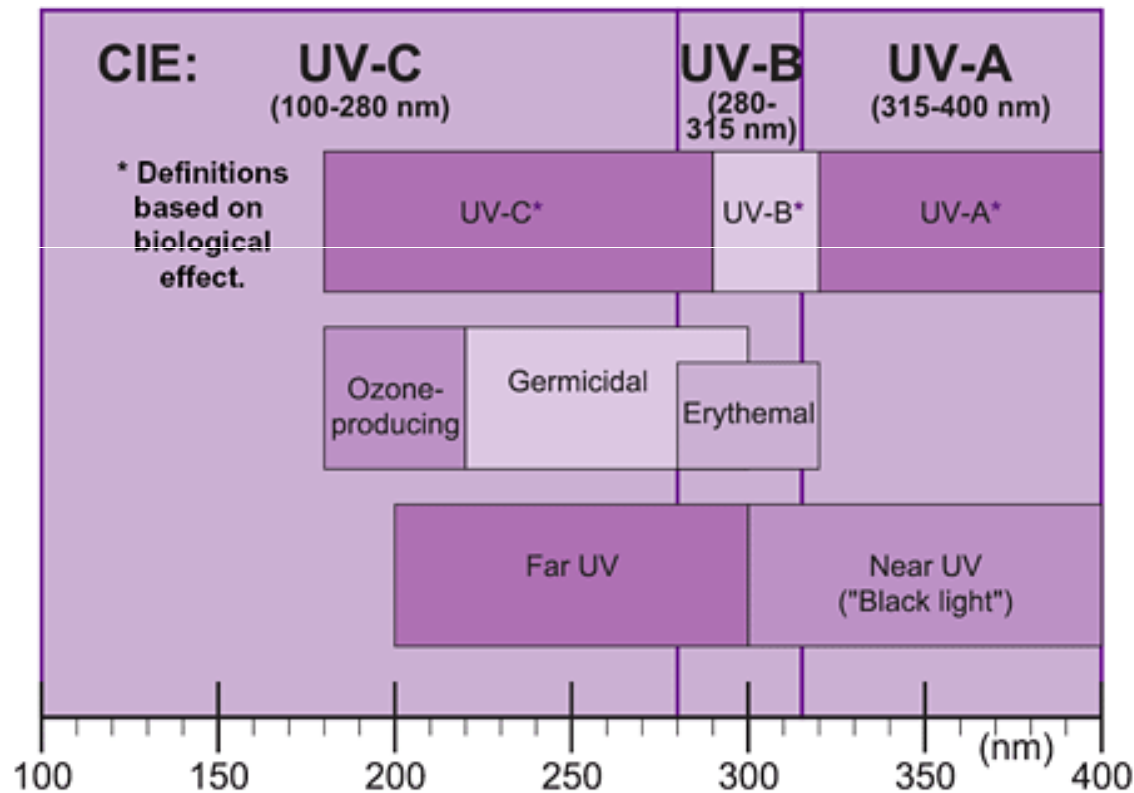
UV Sterilizer (Light Spectrum)

UV light is divided into four groups as measured by wavelength:
(1) Vacuum UV with wavelengths from 100 to 200 nanometers,
(2) UV-C at 200 to 280 nanometers, (3) UV-B at 280 to 315
nanometers, and (4) UV-A at 315 to 400 nanometers.

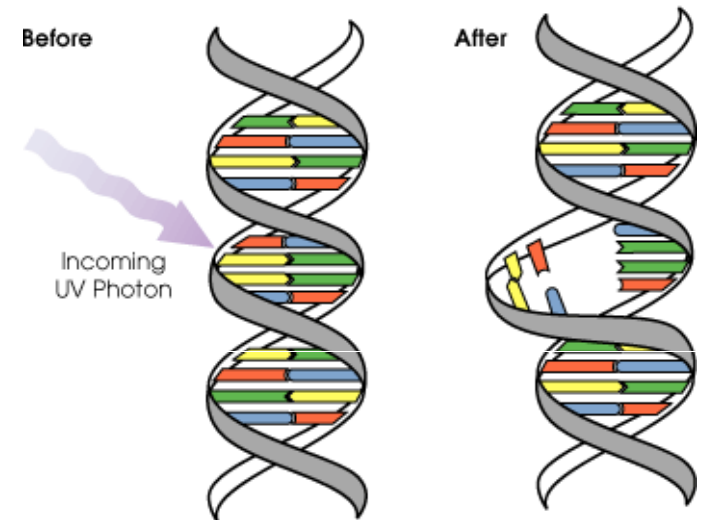
UV Sterilizer

The UV-C spectrum (200 to 280 nanometers) is the most lethal wavelength for microorganisms, because it disrupts the bonds in the between the atoms in the chemicals in microorganisms. This range of wavelengths, with 264 nanometers being the peak germicidal wavelength, is known as the Germicidal Spectrum.

UV light is a safe and natural method to reduce pathogens and algae. UV is as natural as sunlight and does not leave any residuals in the water. It works in harmony with the spa sanitizer by killing some algae and destroying the DNA in others. With the DNA damaged the microorganism can not multiply.

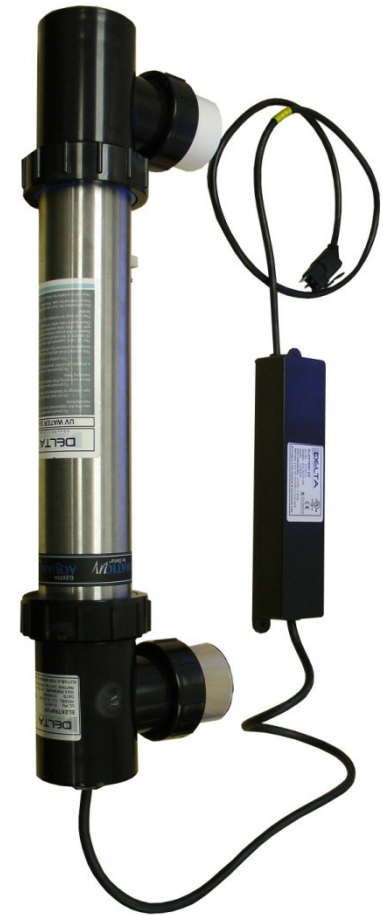
UV Sterilizer

- Water is pumped through the UV chamber where it is exposed to the UV-C band. (Germicidal range).
- The UV-C light penetrates the cell walls of bacteria, viruses and other microorganisms, altering the DNA or the RNA as in the case of viruses.
- This process kills cells so they are no longer able to replicate.
- A spa with a properly sized UV system will kill 99.9% of all the bacteria and microorganisms in the water.
- Because UV does such an efficient job of sanitizing the water, there is less bacteria in the water and therefore less chemicals are needed to sanitize the water.

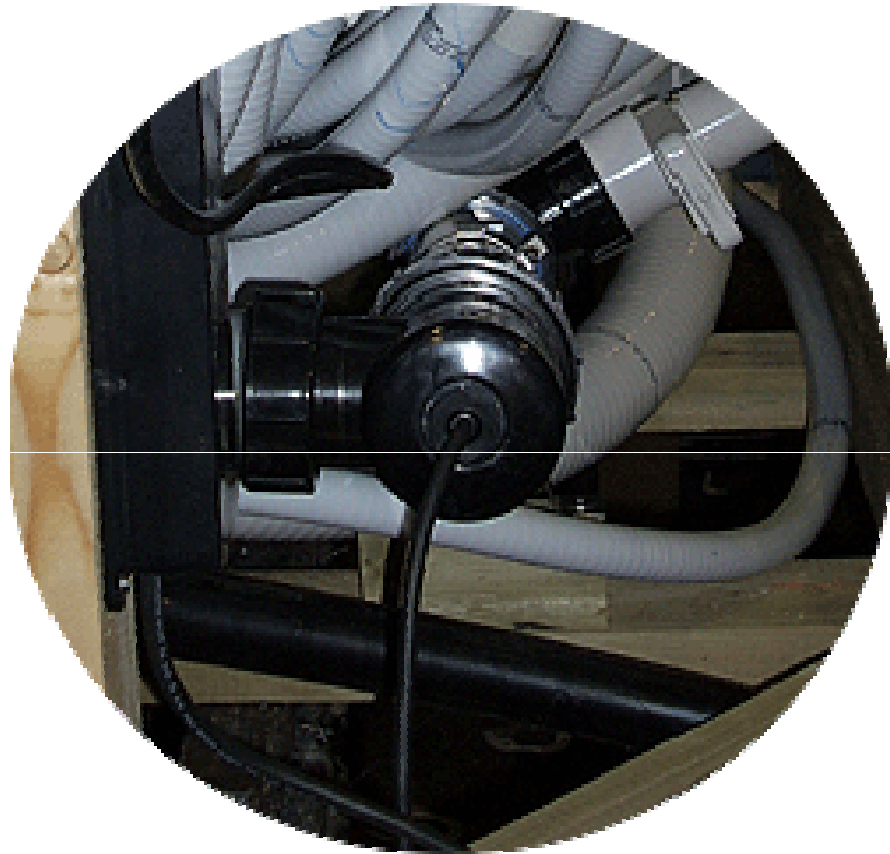
UV Sterilizer (Bulb)

To remove the bulb, unscrew the large black nut on the end of the UV Unit and then carefully pull out the bulb.

Note: the bulb is enclosed in a crystal tube that allows you to remove it with out closing the in and out valves.

Note: do not touch the new bulb with anything including your fingers or damage to the bulb will occur. Always wear gloves when replacing the bulb and only make contact with the tipped ends and not the glass.

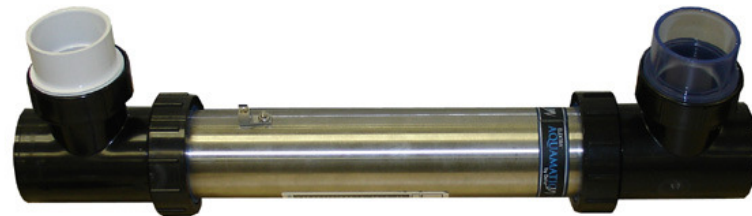
UV Sterilizer (Troubleshooting)

The UV Bulb Will Not Light - If this occurs upon initial start-up, the problem could be caused by a number of issues.

- a. **The bulb has become disconnected from the bulb connector** - Disconnect the power cord

from the electrical outlet, open the electrical enclosure bonnet and confirm the bulb connector is firmly in place. At the same time, check all exposed wires for a possible loose connection. Plug the electrical cord back into the electrical outlet **ONLY** after the electrical enclosure bonnet has been re-installed on the EA unit, and the pump is ON.

- b. **Verify that the electrical cord is plugged into a hot outlet** - Test the electrical outlet. You should confirm the availability of the same power as indicted on the electrical label on your EA unit.
- c. **Make sure you have not plugged your unit into any power source other than that specified on your unit's electrical label** - If you have done so in error, the ballast has been damaged and needs to be replaced. Contact your supplier for the correct replacement ballast.

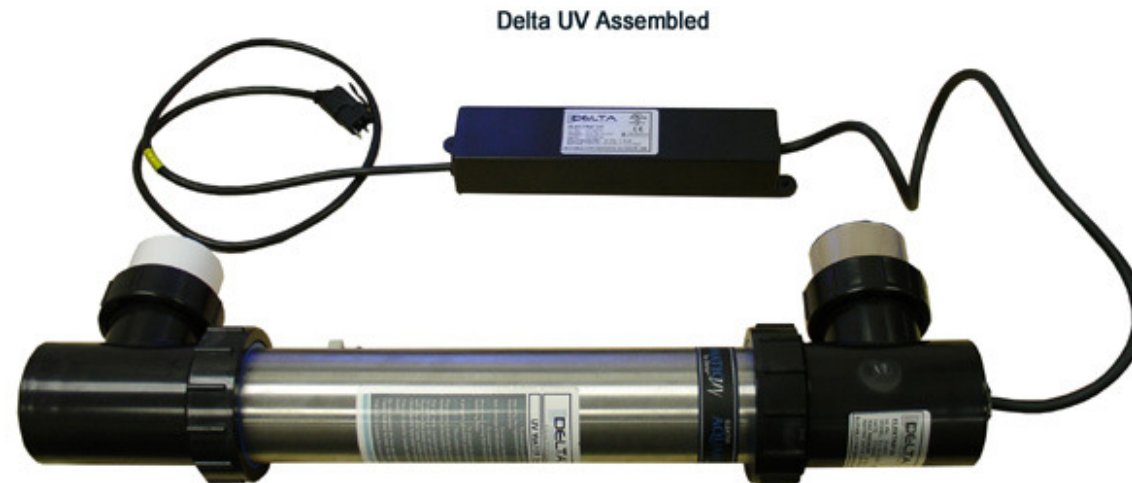
UV Sterilizer (Troubleshooting)

The EA Unit Makes Noise When Operating - This is an indication of the EA unit not being properly attached to a firm mounting base of wood or concrete with the mounting stands and band clamps provided. It can also indicate that the UV bulb was installed without the required bulb cushion and/or bulb O-Rings. Attach the EA unit correctly to a firm base as described in Sec. 5.5, or install the bulb cushion and/or bulb O-Rings as described in Sec. 9.1.

Water Is Coming Out Of Electrical Enclosure - Water exiting the unit through the electrical enclosure assembly can be attributed to either (a) a bad quartz tube seal (Factory installed), or (b) a broken or cracked quartz tube. Check the quartz tube for cracks or breakage as instructed in Sec. 7.0 and Sec. 8.0. Replace the quartz tube assembly if cracks in the quartz tube are found upon inspection.
